**JOTUN**

# Troubleshooting Guide

Jotun Powder School

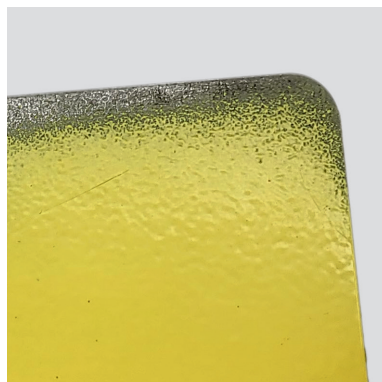
### 1.3 Insufficient earthing of coated objects

Insufficient earthing of coated objects causes low film thickness, insufficient spraying around the hanging points, intensification of the Faraday cage effect, increase of the back ionization effect.

Cause	Solution
Heavily coated hinges and hooks	Regular cleaning of hinges and hooks <ul style="list-style-type: none"> <li>Controlled pyrolysis</li> <li>Chemical cleaning</li> <li>Mechanical cleaning (blasting, hot fluidized bed)</li> </ul> Use blowing nozzles on hinges after spraying

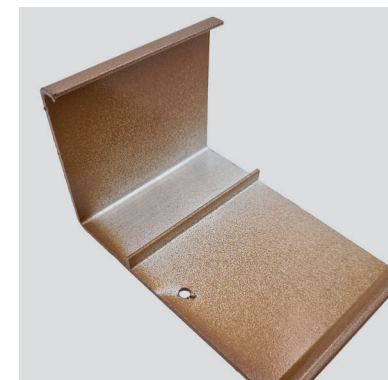
### 1.4 Insufficient penetration of inner recesses, Faraday cage effect

Cause	Solution
Too broad a shape of the powder cloud (e.g., from the deflector nozzle)	Use the slit nozzle
Small amount or velocity of powder	Set sufficient feeding air pressure (amount of powder) and transportation air pressure (velocity of powder)
Insufficient earthing	Check and ensure proper earthing ( $< 1 \text{ M}\Omega$ )
Incorrect direction of the coating application	Correct direction of the coating application
High air flow rate	Adjust air flow rate according to the coated material
Charging voltage is too high (Corona application)	Decrease the charging voltage

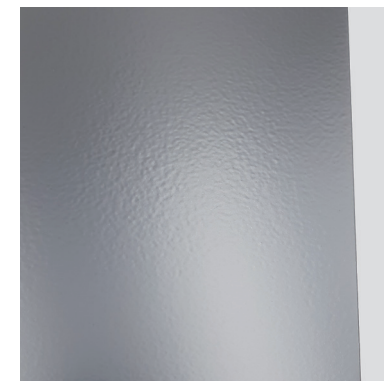
## 1.5 Back ionization (overcharging of the powder coating layer)

Commonly occurs with Corona application, minimally with Tribo application.

Cause	Solution
Excessive film thickness	Apply film thickness recommended in TDS Adjust powder output
High charging voltage and current	Decrease the charging values Use automatic charging current regulation function (standard for newer Corona guns) Use the free ion collector
Insufficient earthing	Check and ensure proper earthing (< 1 MΩ)
Gun is too close to the object	Appropriate distance between the gun and the object (in general, 15-25 cm is ideal)
High proportion of fine powder (e.g., recycled powder)	Keep sufficient proportion of fresh powder (ideal ratio is 70:30 of fresh to recycled powder)
Complex geometry of coated objects	Use appropriate hanging technique Check gun configuration
Spraying one spot for too long	Avoid concentrating the electrostatic field to one spot, use appropriate spraying technique

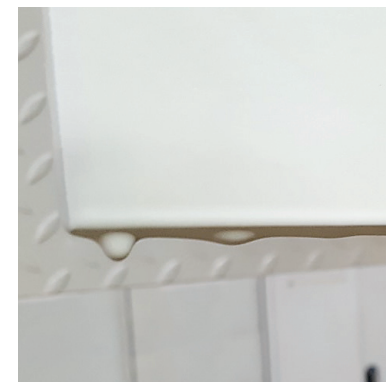
## 1.7 Sagging

Cause	Solution
Piling up on edges	Make sure the recommended film thickness is kept Decrease the charging voltage Use appropriate hanging technique Use a "powder thief" - a dummy object to spread the electrostatic field
Excessive film thickness	Apply film thickness recommended in TDS
Slow heat-up rate	Ensure adequate temperature rise during the curing process Use IR booster
Unsuitable powder formulation for the given use	Use a more reactive powder, consult the powder manufacturer

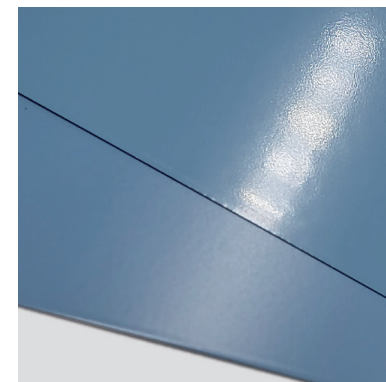
## 1.9 Gloss difference

Cause	Solution
Overcuring, temperature too high and/or curing time too long	Prevent overcuring – correct setting of temperature/time according to TDS
Gloss influenced by gas burning residues (in direct gas ovens)	Use powder resistant to gas-oven residues
Contamination by incompatible powder coating – creation of pinholes	Avoid mixing with incompatible powder coating
Incorrect film thickness – creation of the „frozen” effect due to excessive thickness	Apply film thickness recommended in TDS

Cause	Solution
Insufficient curing time and/or curing temperature is too low	Ensure sufficient curing – measure the temperature profile of the oven, use correct setting of temperature/curing time

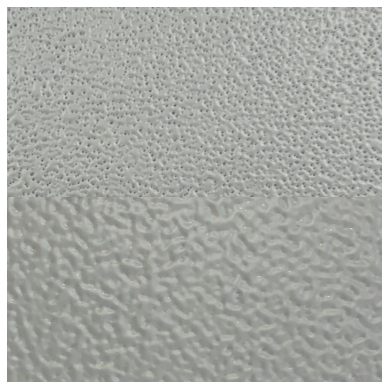
### 1.10 Incorrectly structured finish

Cause	Solution
Holes reaching to the substrate: low film thickness	Apply film thickness recommended in TDS
Flat finish, incomplete texture, fine texture too rough: <ul style="list-style-type: none"> <li>Excessive film thickness</li> <li>Heat-up rate is too slow (heavy pieces, slow rise of temperature in the oven)</li> </ul>	Apply film thickness recommended in TDS Ensure adequate temperature rise during the curing process
Insufficient earthing	Check and ensure proper earthing (< 1 MΩ) Use clean hooks
Incorrect distance of the gun from the object	Appropriate distance between the gun and the object (in general, 15-25 cm is ideal)

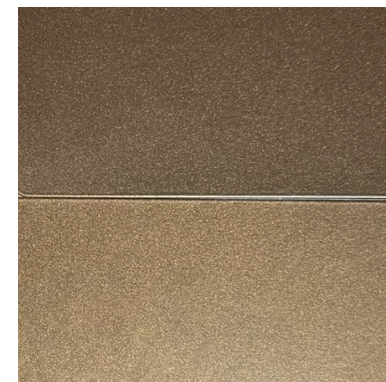
### 1.11 Changes of metallic effect

Cause	Solution
Separation of metallic pigment during the recycling process (excessive proportion of recycled powder in the system)	Use bonded metallic powder instead of dry-blended Ensure continuous and sufficient feeding of fresh powder into the system (ideal ratio is 70:30 of fresh to recycled powder)
Charging values are too high (Corona application)	Decrease the charging values
Insufficient earthing	Check and ensure proper earthing (< 1 MΩ)
Insufficient fluidization	Secure correct fluidization

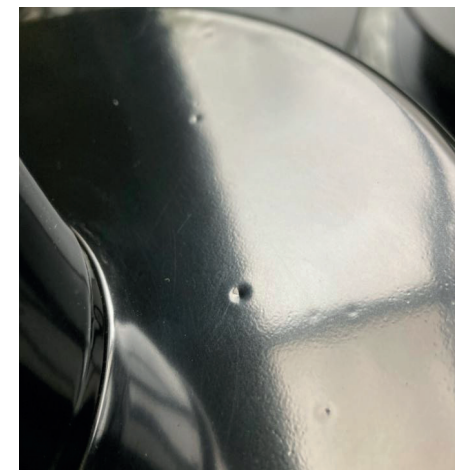
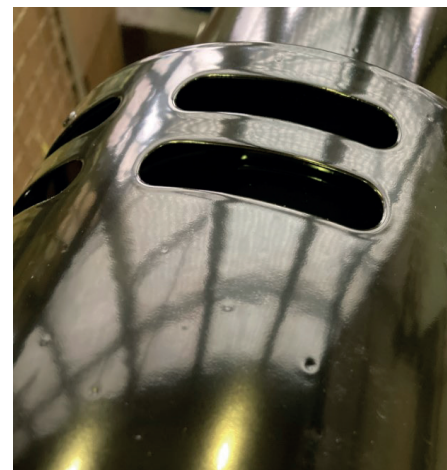
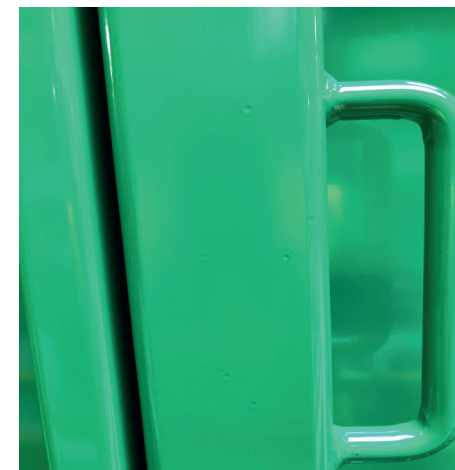
## 1.14 Craters and defects from degassing of porous substrates

Cause	Solution
Contamination from silicones, oil, vaseline, grease	Eliminate all silicone-based materials from the paint shop and clean the booth system Avoid using oil-based spray Use only approved lubricants for conveyors etc.
Contamination by incompatible powder coating	Clean the booth system and the paint shop
Insufficiently degreased substrate	Test pretreatment conditions, adjust where necessary
Presence of oil and humidity in compressed air	Check the air filter Consult the maintenance department Check compressed air system (in general, dew point < 3 °C, oil content < 0.1 ppm, particle size < 0.3 micron)
Highly porous substrate releasing gases creating closed or opened bubbles	Degassing by high temperature in the oven before coating Use powder for porous substrates – “degassing” products

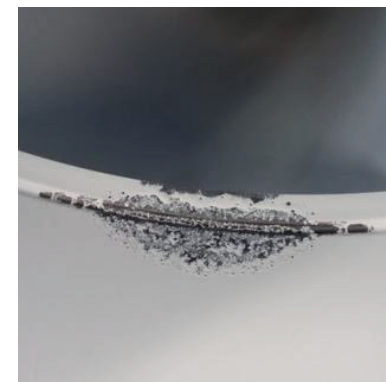
## 1.16 Water residues

Cause	Solution
Water residues from pretreatment	Use appropriate hanging technique
	Secure technological holes for drainage of hollows
	Ensure sufficiently high temperature and sufficiently long drying process – but avoid burning of the conversion layer (generally, chromate < 90 °C, phosphate < 120 °C, nanoceramic < 160 °C; always follow the pretreatment supplier's recommendation).

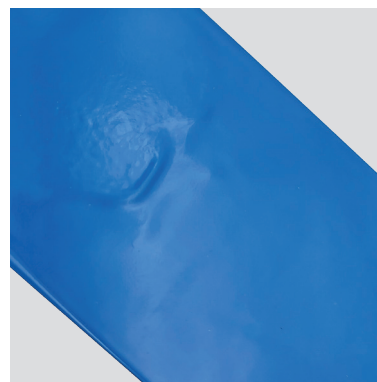
### 3.1 Powder pumps

Damaged pumps may lead to lower corrosion resistance, shine-through of the substrate, incorrect surface appearance.

Cause	Solution
Worn-out or clogged ejector inserts	Regular checks and replacement of ejector inserts
Incorrect setting of ejection and transportation air pressure	Correct setting of feeding and transportation air pressure: optimal amount and speed of powder in order to reach maximum efficiency of spraying the powder – ideal thickness, minimum of powder to be recycled

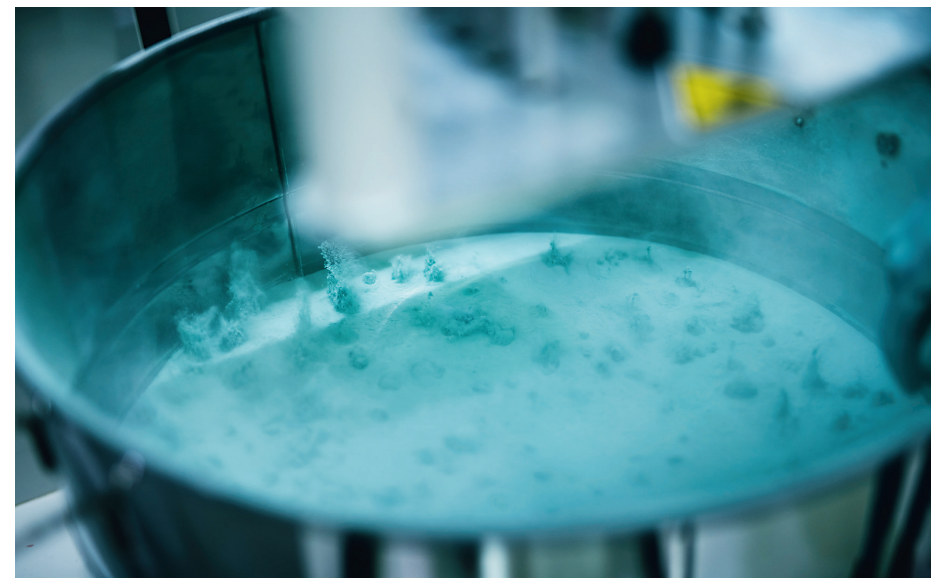
### 3.2 Hopper – fluidization

Correct fluidization is necessary for pumping and transporting powder to guns. Incorrect fluidization can cause insufficient or irregular feeding of powder into guns leading to irregular film thickness, spitting.

Cause	Solution
Blocked or defective fluidizing membrane	Regular checks of fluidized bed condition, its tightness
Inadequate air pressure	Set the appropriate fluidization air amount; small amount causes incorrect fluidization, excessive amount causes wild fluidization (dust rising, excessive amount of air in the mixture)
Moist powder	Follow storage conditions (up to 25 °C and 60 % humidity) Check powder expiry date Check compressed air system (in general, dew point < 3 °C, oil content < 0.1 ppm, particle size < 0.3 micron) Humidity could be removed by sufficiently long fluidization
Powder affected by too high temperatures	Consult powder coating manufacturer
High proportion of fine powder (e.g., recycled powder)	Keep sufficient proportion of fresh powder (ideal ratio is 70:30 of fresh to recycled powder) Secure fluent feeding of the powder Reduced content of the free-flow additive, contact powder coating manufacturer

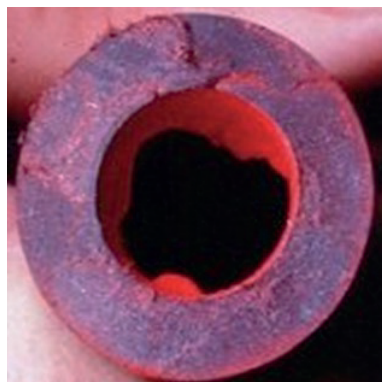
### 3.3 Clogging of hoses, impact fusion

Cause	Solution
Pinched hose, sharp bends, excessive wear and tear	Choose suitable hose type with adequate length and diameter, recommended by supplier Regular checks, cleaning and replacements of hoses
High or low air flow rate	Adjust the air flow rate
